**Subject: TCEQ Dam Safety Inspection for:  
Inventory No. TX07227 - Oak Hollow Dam  
Smith County**

### **DAM SAFETY INSPECTION REPORT**

INVENTORY No.: TX07227

DAM: Oak Hollow Dam

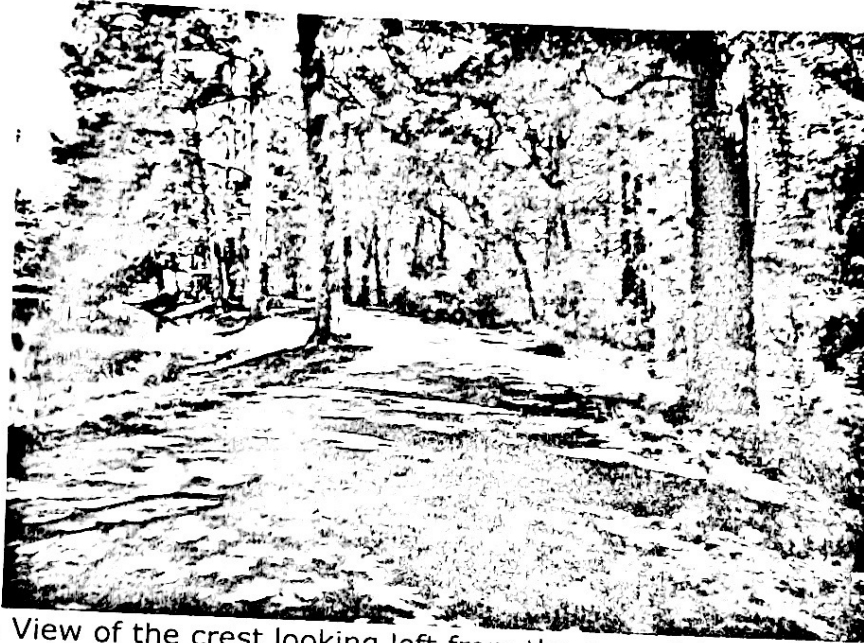
**Photo 1.** View of the crest looking left from the near right end of the dam. Note the tree growth along the edge of the crest and slopes.

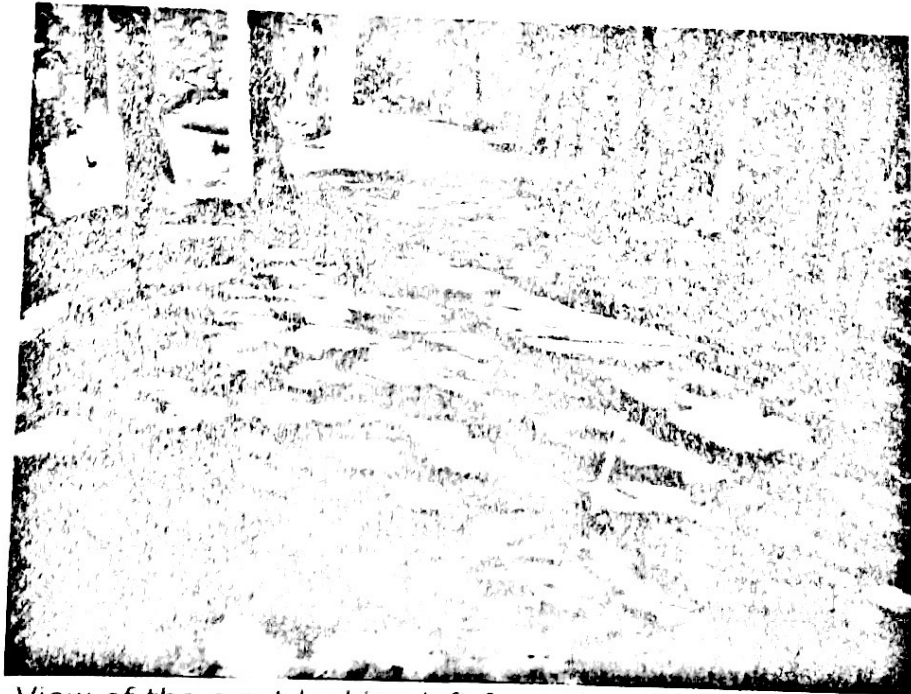
**Photo 2.** View of the crest looking left from the middle of the dam. Note the tree roots across the crest (arrow).

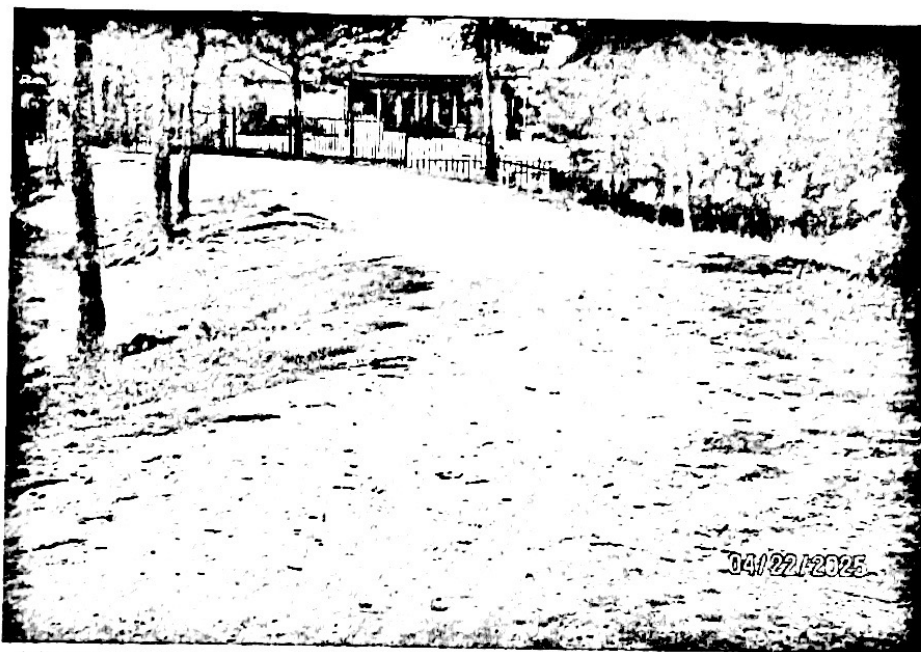
**Photo 3.** View of a low spot (dashed lines) along the left end of the dam looking left. Note that a foot path traversed the low spot, which leads from the shoreline to the downstream toe area.

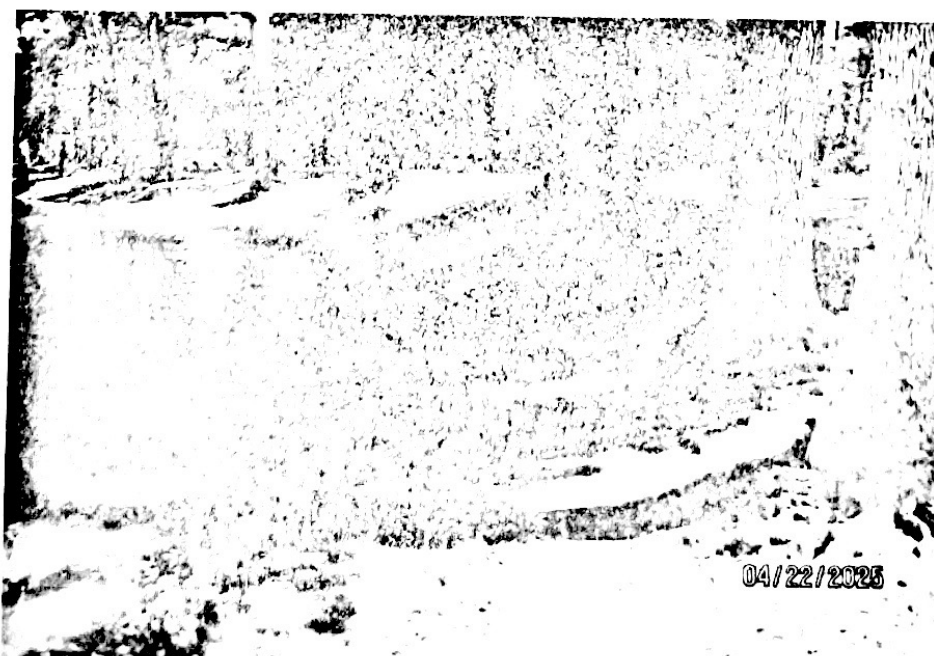
**Photo 4.** View of the upstream slope looking left from the near right end of the dam. Note the large trees and exposed roots along the shoreline.

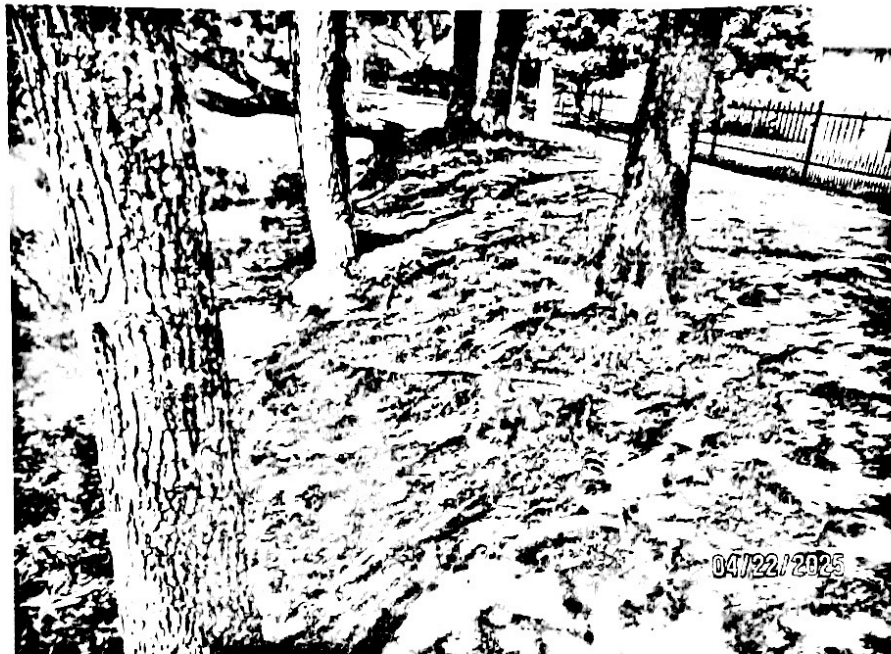
**Photo 5.** View of the upstream slope at the left end of the dam looking left. Note the tree growth and exposed roots along the uneven upstream slope.

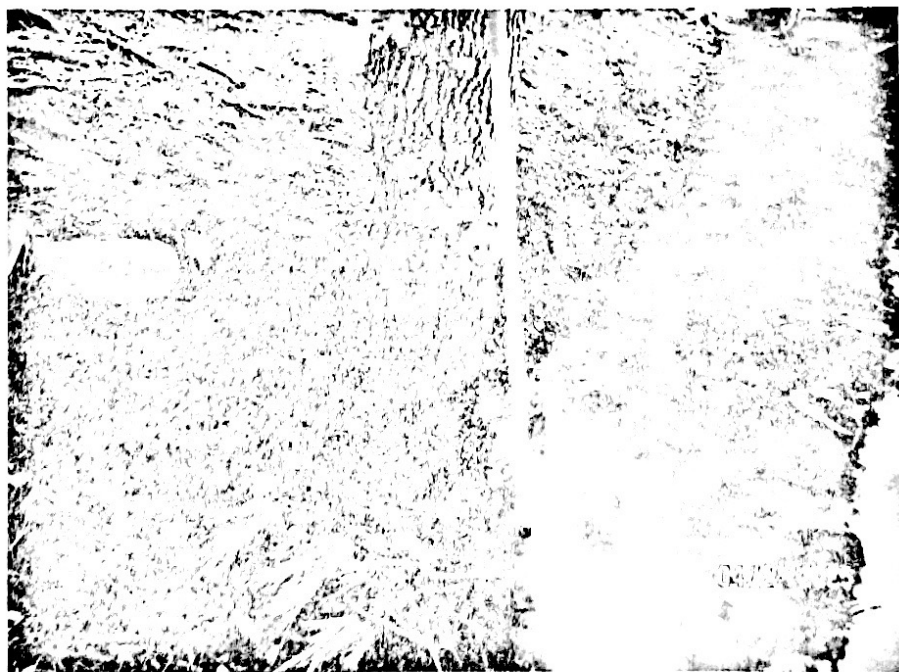
**Photo 6.** View of some benching occurring at the base of a tree along the shoreline. Note the benched area was about 8-inches high.

- b. Monitor benching and exposed tree roots along the shoreline. If the condition worsens, then the options to armor the upstream shoreline should be discussed with your PE.

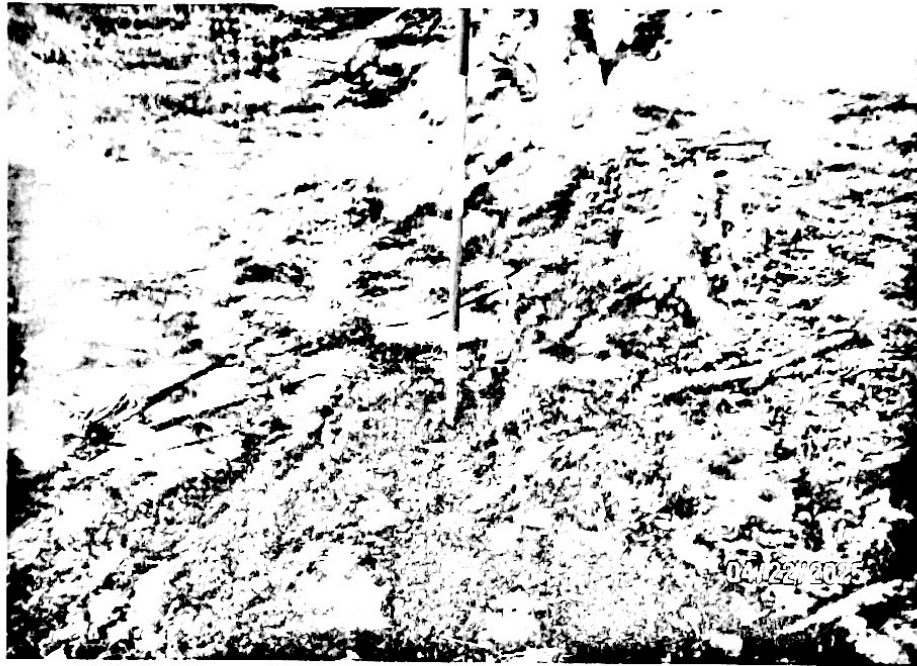
**Photo 7.** View of upstream slope near the left end of the dam looking left. Note the uneven slope (minor benching) and exposed tree roots along the slope.

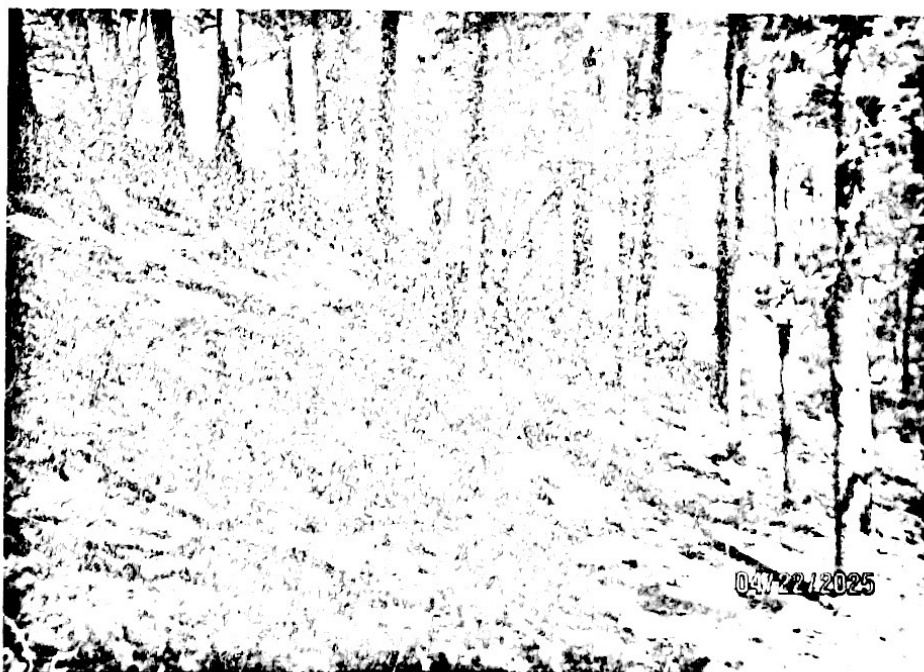
**Photo 8.** View of the downstream slope looking left from the middle of the dam. Note the tree growth, scattered dry wood debris, and dry leaves ground cover.

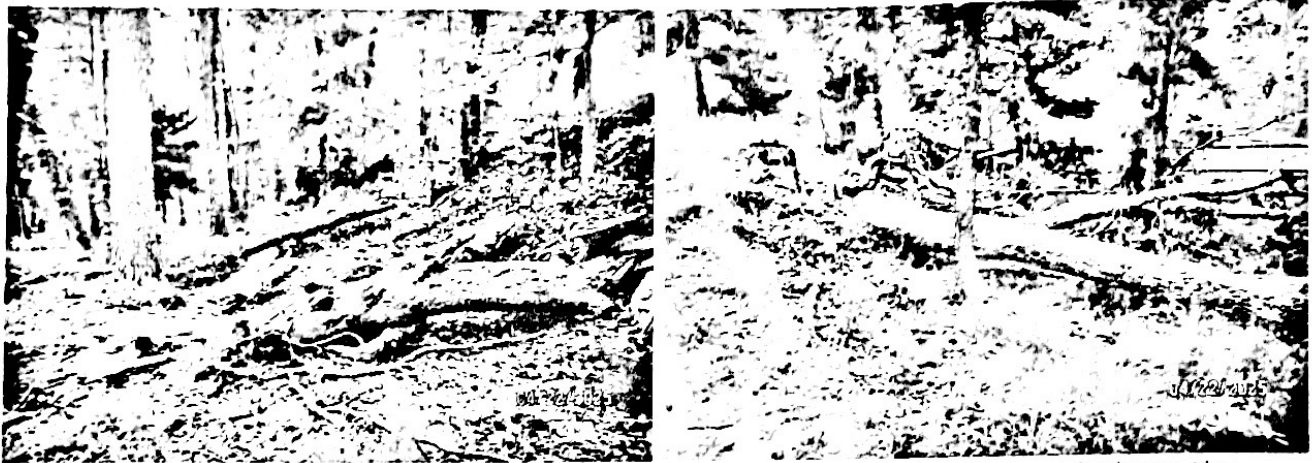
**Photos 9A & 9B.** View of the scattered large tree debris observed along the near left end of the dam looking right and left, respectively.

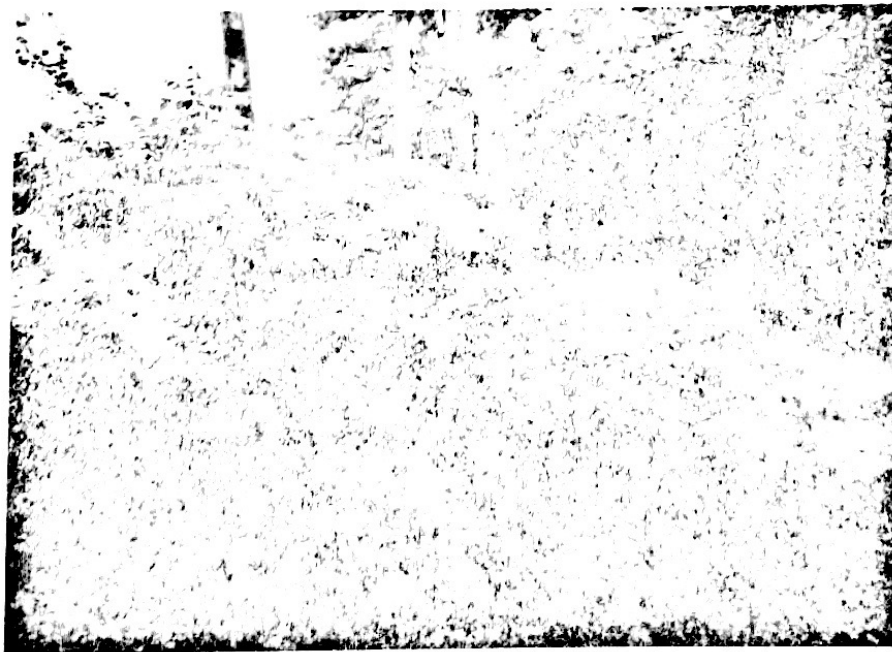
**Photo 10.** View of a pile of dry brush and tree debris observed along the right end of the downstream slope.

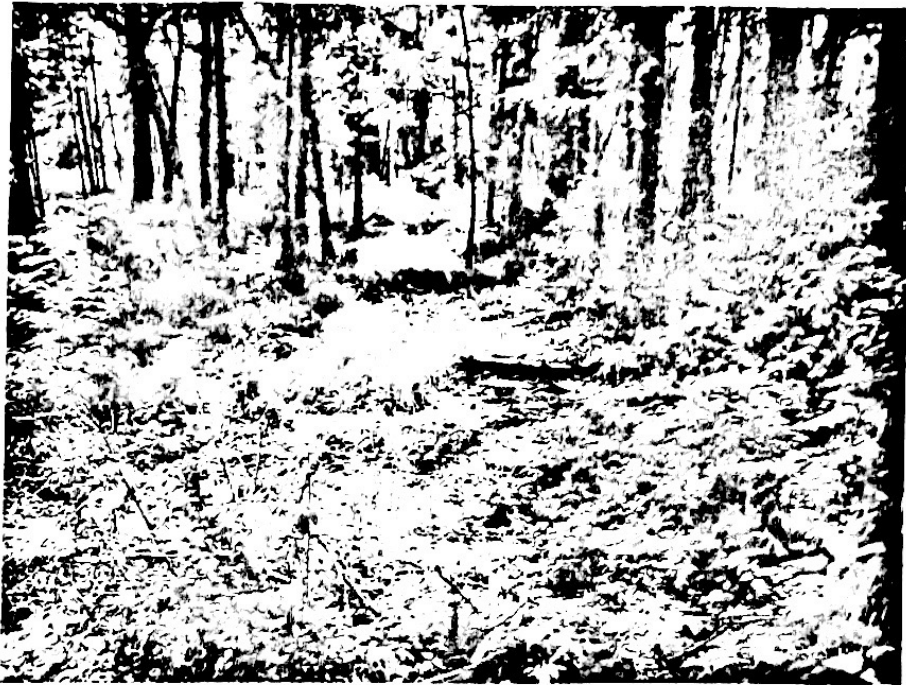
**Photo 11.** View of the downstream toe area near mid-dam, looking right. Note the overgrown brush and tree growth.

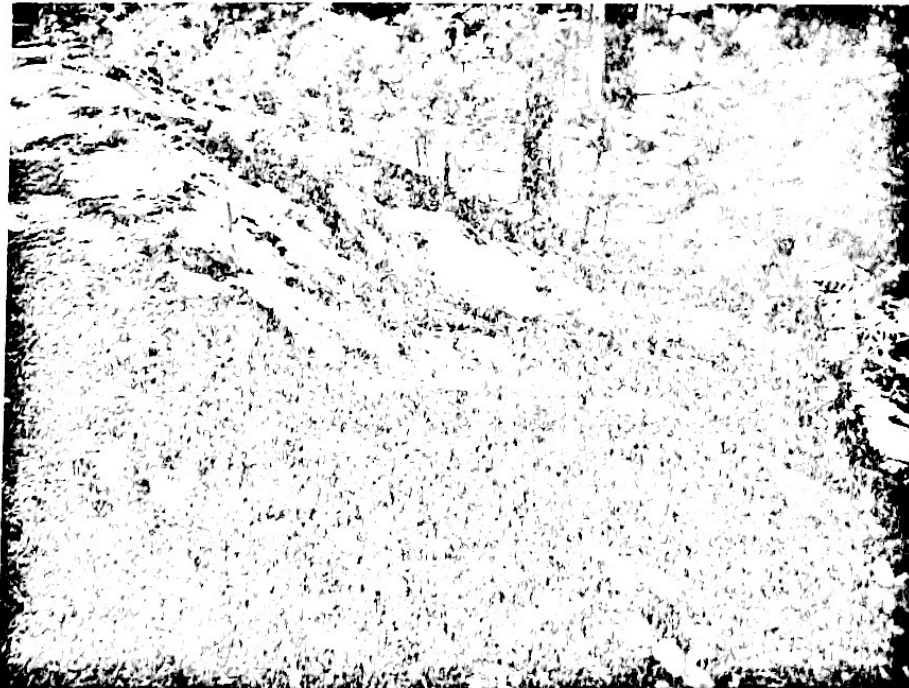
**Photo 12.** View of an erosion gully (dashed line) along the edge of the crest and downstream interface, near the right end of the dam. The gully was not measured and was covered by a dry ground cover of pine needles and leaves.

5. A plan should be established to repair erosion damage and gully along the edge of the crest/downstream interface by first clearing out area, then backfill and properly compact the affected area with non-dispersive fill. Protect the repaired areas from a recurrence by re-establishing a good grass cover. Any plans and specifications for these repairs are required to be submitted to the TCEQ Dam Safety for review and approval before any work is started.

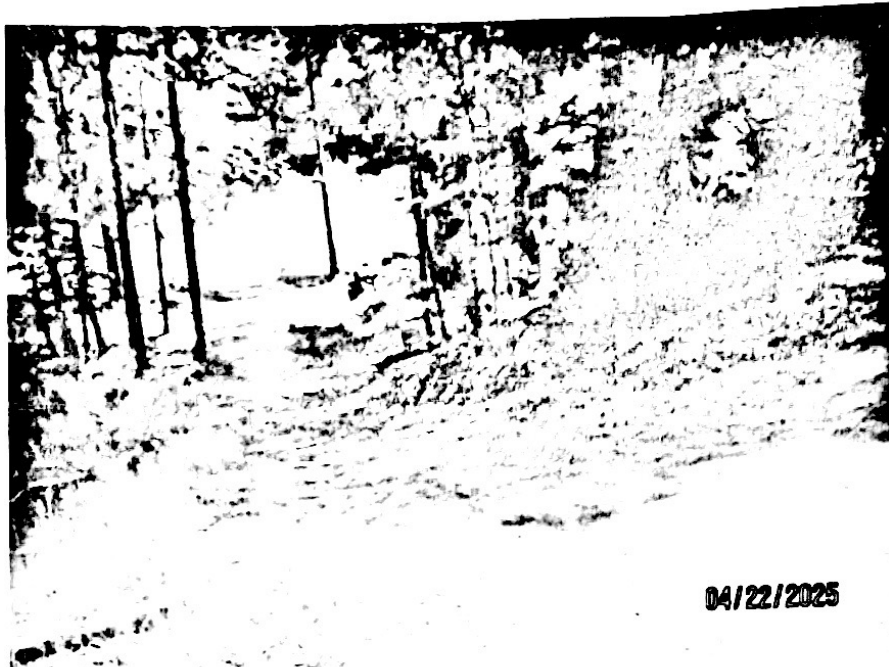
- The previously noted pedestrian trail near the left end of the dam is still present; however, appeared unchanged from the last inspection. Some minor erosion was observed on the trail.
- The downstream slope was found to be in fair condition.

**Photo 13.** A view of a previously noted trail leading to the downstream toe from the crest. The trail was located along the left end of the dam and appeared unchanged from the last inspection.

- a. Monitor trails throughout the embankment, primarily along the downstream slope near the left end of the dam. If trails worsen then they should be repaired, and vegetation allowed to regrow.

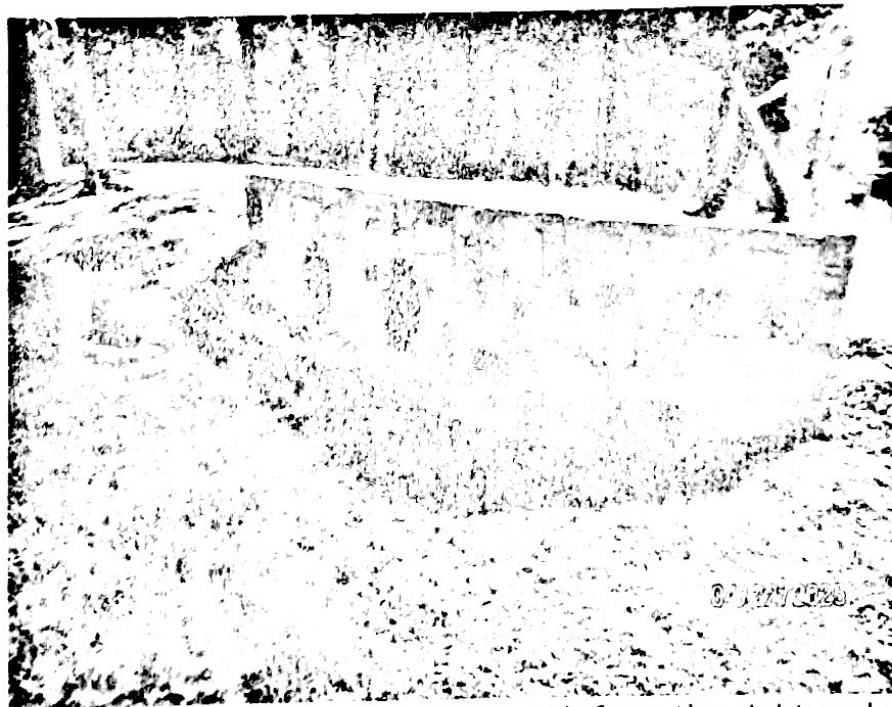
**Photo 14.** View of spillway structure approach from the right end of the dam looking left. The direction of flow is noted by the arrows.

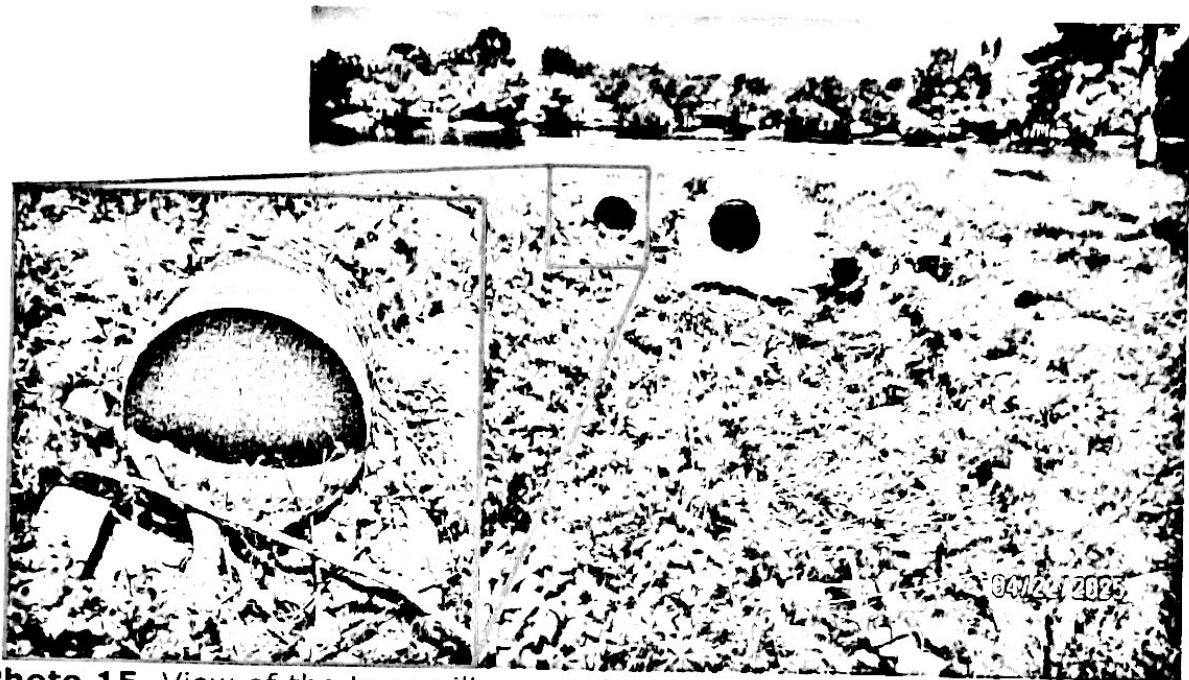
- The spillway outlet pipes were generally clear, with some minor vegetative debris on the right outlet pipe.
- The surrounding concrete headwall structure was deteriorated and undermined, primarily along the left side by about 3-feet deep.

**Photo 15.** View of the two spillway outlet pipes at different elevations and a deteriorated headwall structure, looking upstream. Note the accumulated debris at the end of the right outlet steel pipe. Also note that the pipe adjacent to the steel pipe is a High-Density Polyethylene (HDPE) pipe. The direction of flow is noted by the arrows.

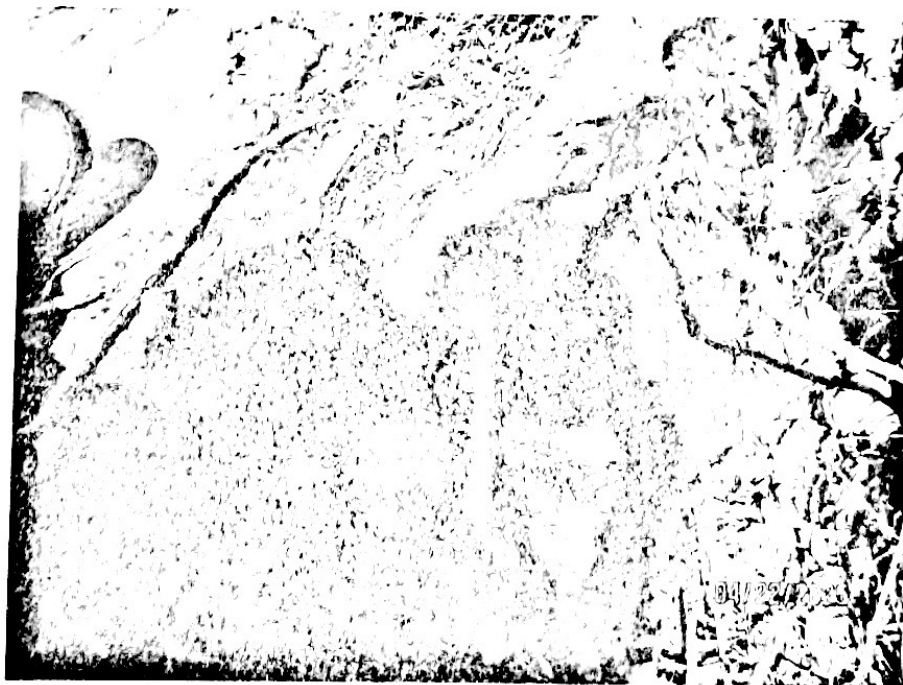
**Photo 16.** View of an undermined area along the left side of the concrete headwall structure. The area was probed at about 3-feet deep.

4. Undermining erosion beneath the concrete headwall outlet structure and erosion damage to the left of the spillway outlet pipes should be repaired. The affected area should be backfilled with properly compacted non-dispersive clay, re-graded, and re-establish a vegetative cover.

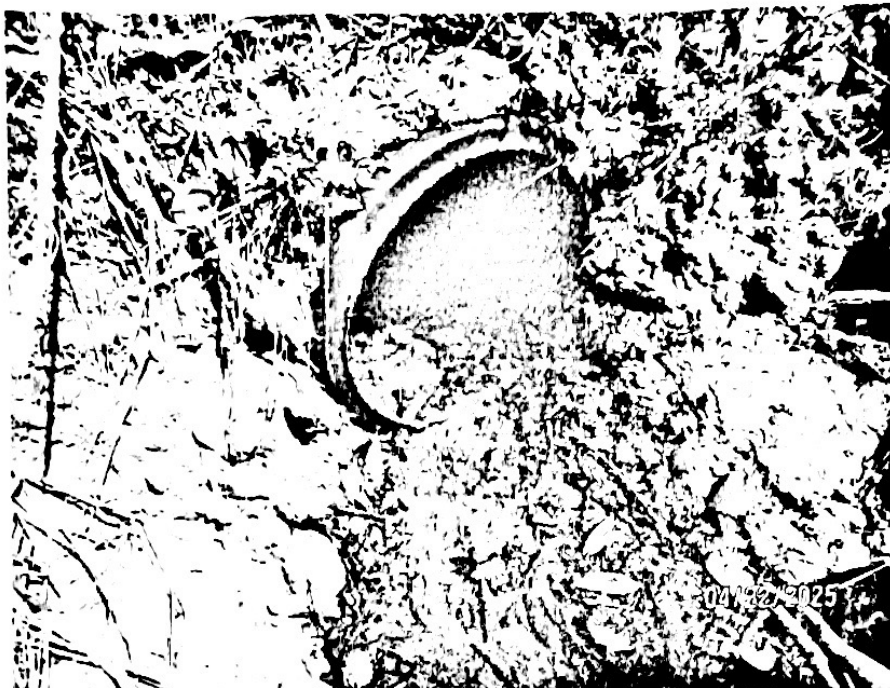
- A 12-inch diameter HDPE pipe was observed on the downstream side of the spillway; however, not visible along the upstream headwall structure. The pipe appeared to be leaking; however, no active flow was observed.

**Photo 17.** View of an HDPE pipe observed on the downstream side of the spillway; however, not visible along the upstream headwall structure. however, appeared to be leaking.

7. The leaking 12-inch diameter HDPE pipe observed on the downstream side of the spillway should be further inspected by your PE.
8. Silt accumulated and obstructing conveyance at the 24-inch HDPE pipe along the downstream channel should be cleared and monitored after every spillway engagement.

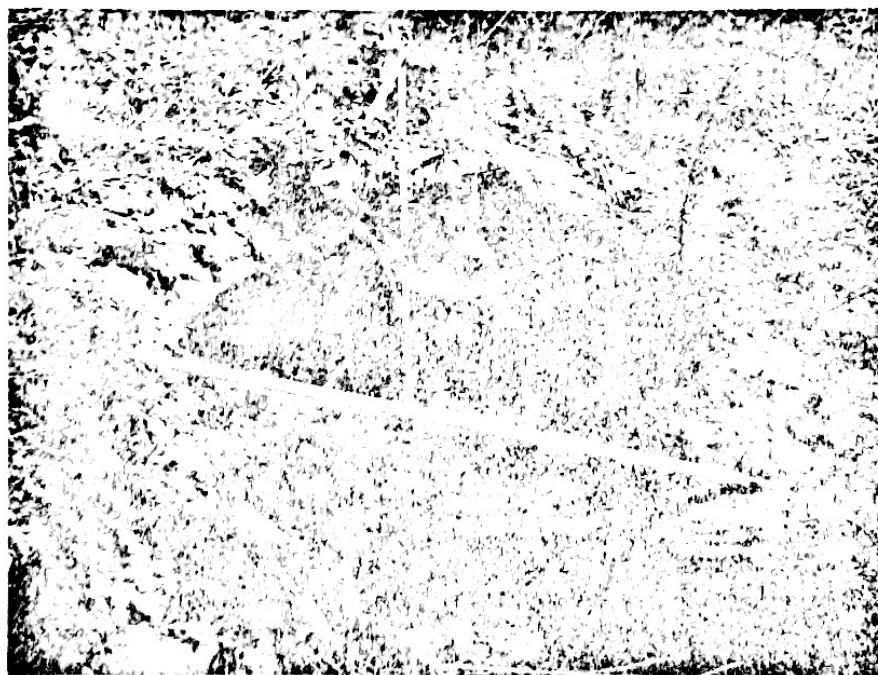
- Erosion damage was observed just to the left of the spillway outlets. The eroded area was about 3.5-feet wide and 27-inches deep.
- The service spillway was found to be in overall fair condition.

**Photo 18.** View of an eroded area just to the left of photo 16. The eroded area was about 3.5-feet wide and 27-inches deep.

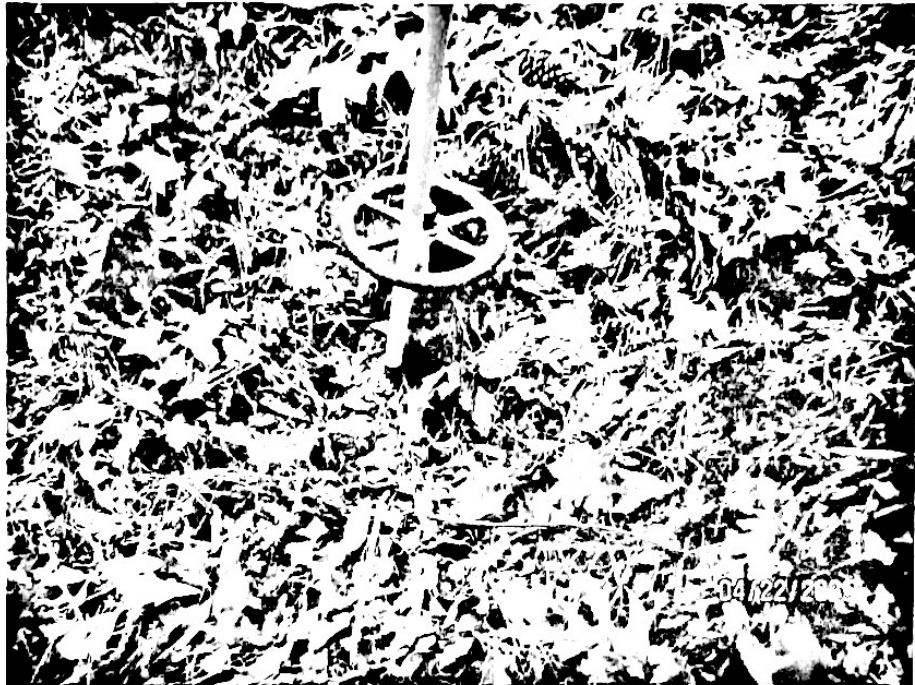
- The low flow system is located near the center of the dam. The inlet pipe was not observed, and it is most likely in the reservoir; however, the outlet pipe was observed along the downstream toe.
- The valve stem with operator was located mid-way up the downstream slope in-line with the pipe.
- The valve stem and operator wheel were partially covered by dry ground, pine needles, and leaves.
- Standing water was observed in a small pool just downstream of the low flow outlet pipe. The pool was about 2-feet deep, and it was not determined if the standing water was being fed by the leaking low flow or simply from runoff. Note this was a different pooled area than the one mentioned in the 2019 report.
- The operational condition of the low flow system is unknown.

**Photo 19.** View of the low flow valve stem and operator wheel partially covered by dry cover of pine needles and leaves.

9. The low flow system should be further investigated by your PE. If the low flow is ever inspected and functional then it should be exercised at least on an annual basis to ensure it is in good working order and capable of lowering/draining the reservoir should an emergency situation ever warrant such. If the gate has not been operated for a substantial period of time, it is recommended that your PE devise a plan to assess the functionality and ensure that the gate does not get stuck open and unduly drain the reservoir. The wheel for the gate valve should be locked in place for security measures if the outlet is to be used as described above.

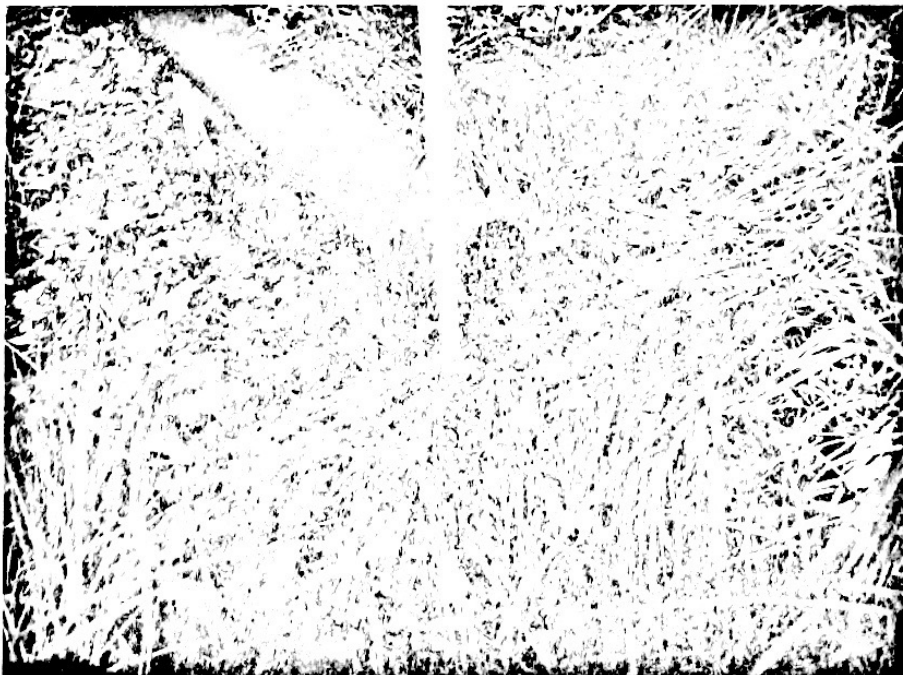
**Photo 20.** View of the steel 6-inch diameter low flow outlet pipe observed along the downstream toe area.

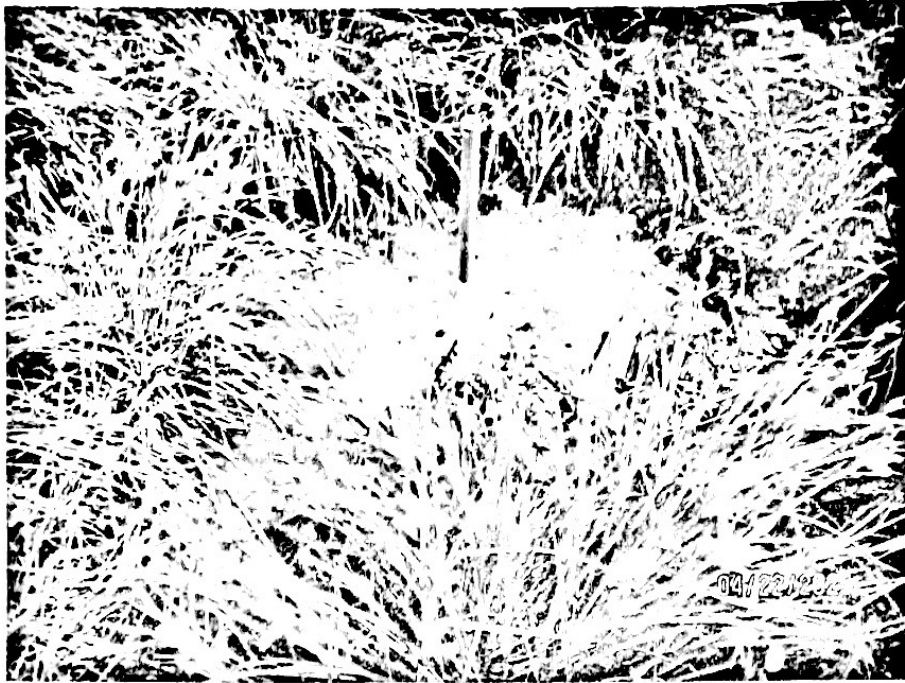
**Photo 21.** View of standing pool of water (about 2-feet deep) just downstream of the low flow outlet pipe. It was not determined if the standing water was being fed by the leaking low flow or from runoff.

- c. Monitor the standing pool of water downstream of the low flow outlet pipe.
- d. Monitor any erosion occurring along the downstream channel.
- e. Routine safety inspections should be conducted on a periodic basis and immediately after a significant rain event to evaluate the condition of the structure and detect and address problems before they progress to a serious level. These actions will minimize the cost of dam maintenance and repair activities as well as minimize risks and liabilities associated with dam safety issues.

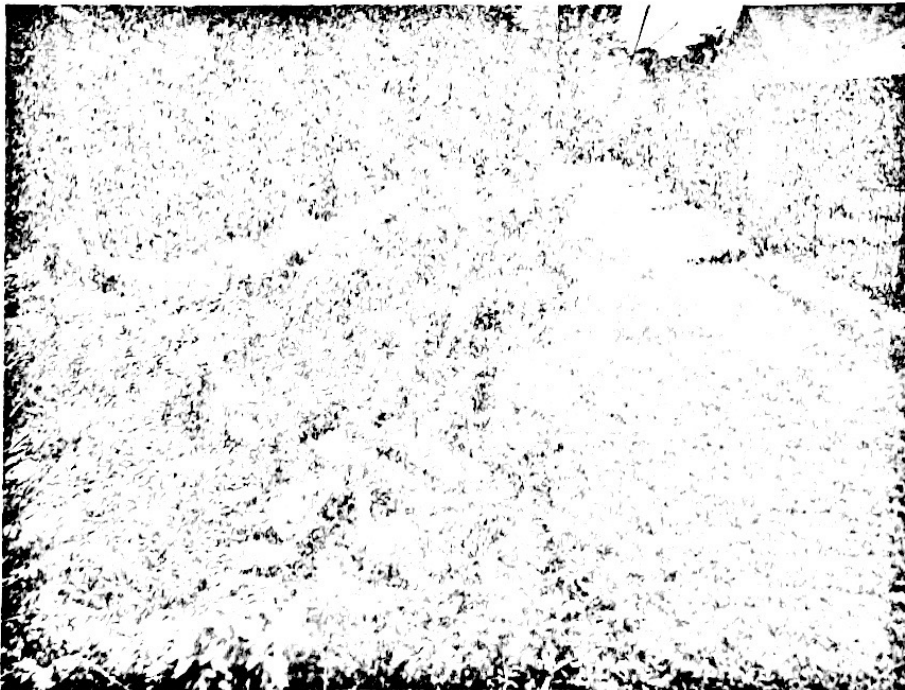
**Photo 22.** View of the shallow channel just downstream of the spillway outlet pipes looking downstream. Note the overgrown brush and grass within the shallow channel (dashed lines). The direction of flow is noted by the arrows.

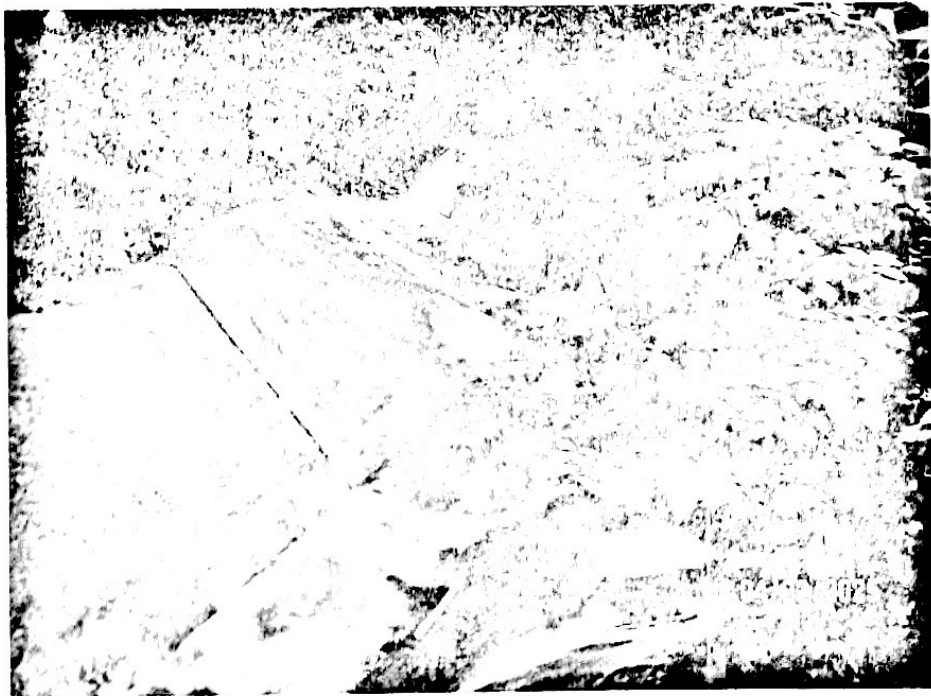
**Photo 26.** View of the trapezoidal concrete channel at the bend looking downstream. The direction of flow is noted by the arrows.
